Coal Ash Disposal Landfill Annual Site Inspection

NELSON POWER GENERATING STATION

January 2019

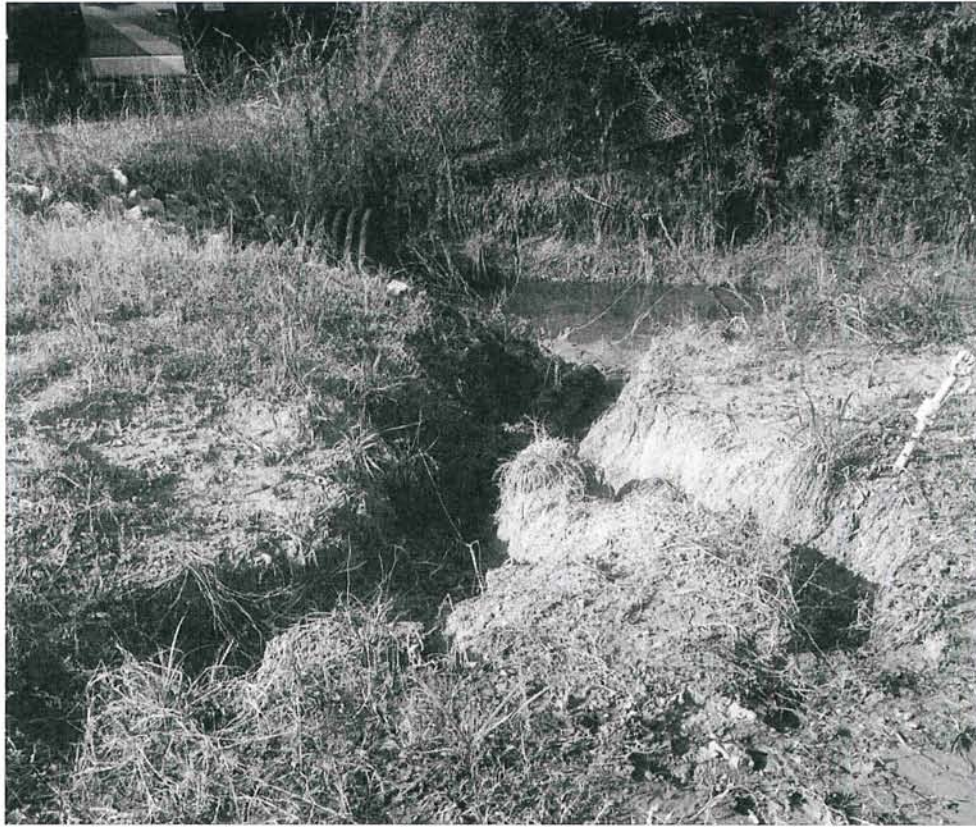
Pivotal noted changes to the geometry of the internal stockpiles at the CADL as well as the perimeter levees and ditches. Erosion was observed at the exterior perimeter ditch on the southwest corner facing west (Photo 15). None of the observed changes will affect the stability of the CCR unit. Maintenance will be performed on the exterior perimeter ditch area (shown on Photo 15) to replace the volume of eroded material.

Photo 15: Southwest corner facing west into the exterior perimeter ditch.
